ENGINEERING ASSESSMENT AND DESIGN REPORT

**Lot 2 136 State Highway 26,
Hamilton**

25 FEBRUARY 2022

PROJECT NO. 11122

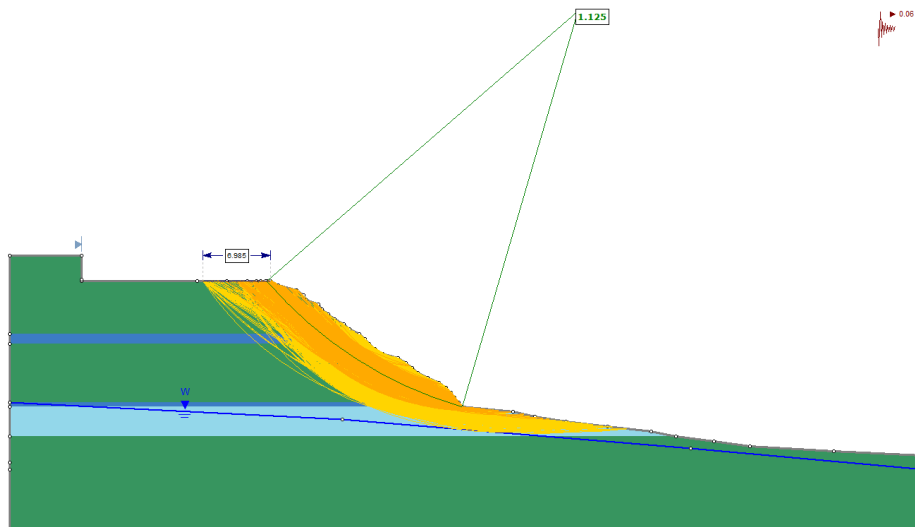
- We confirm that the septic and rainwater tanks are setback 7.0m from the top of slope, as per the slope stability modelling under gravity and SLS conditions (IL1) the slope is considered stable.

As below the SLS case provides the critical setback requirement.

Slope model failure arcs with FOS<1.5 shown for ILS SLS Case

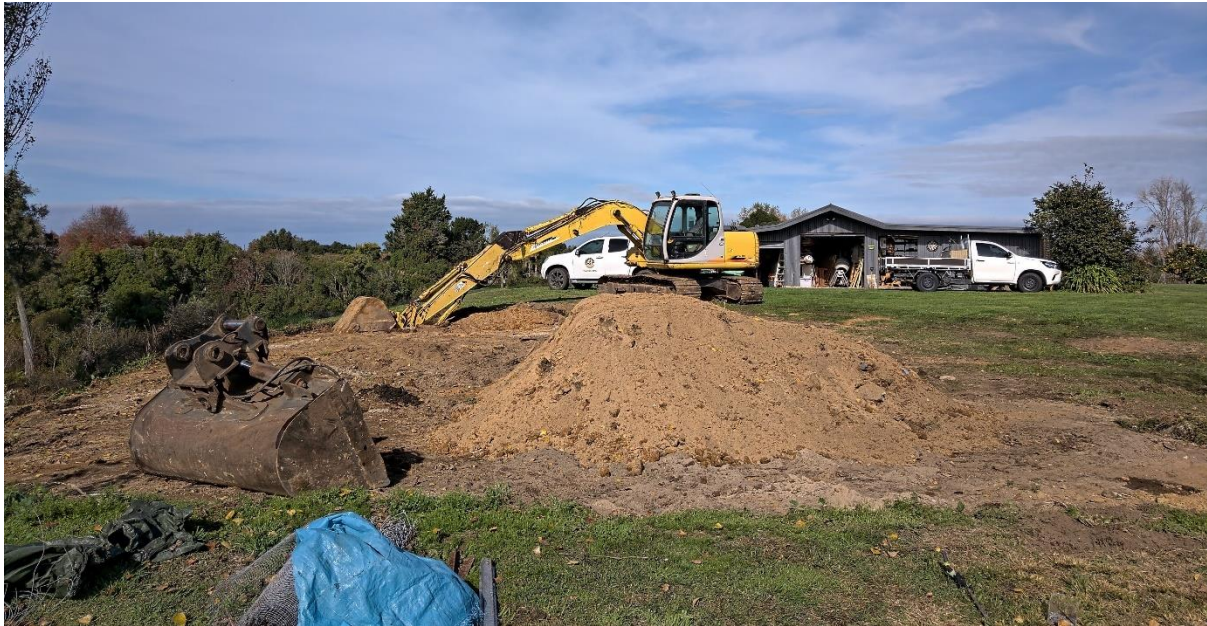
Figure 1: Site Photo

The site is currently a newly subdivided lifestyle block with a large gully at the back of the section. The site is bordered by a gully system to the east, a field to the north (used for cultivation), and a residential house and garage to the south / south west. The area near the proposed foundation is gently sloping to the north. The location of the house is close to the top of a slope joining the gully system to the east.

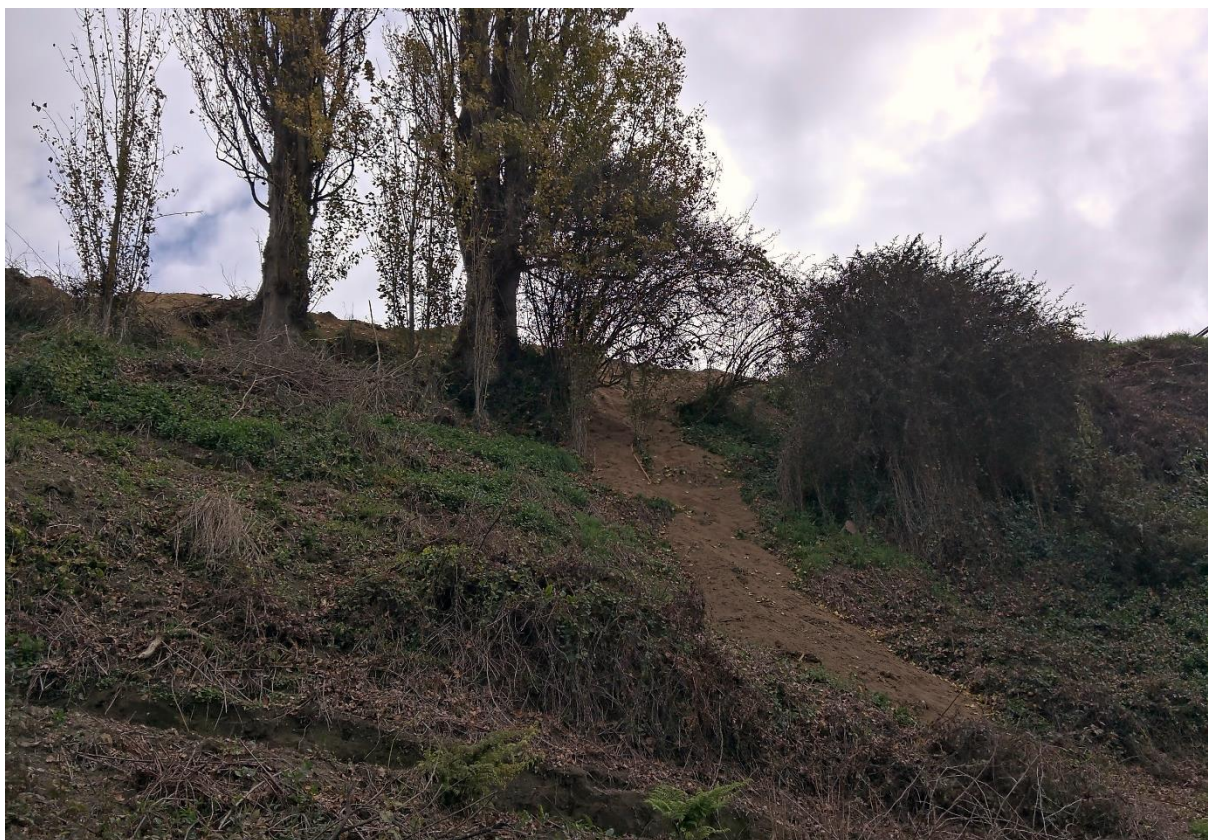
The slope ranges in steepness from 7 degrees to a maximum of 40 degrees with an average slope of 27 degrees or 51% incline. Two large poplar trees are present at the top of the slope. Figure 3 below shows the slope below the proposed dwelling location. The loose material seen on the slope in Figure 3 is sand from the removal of the milking shed foundation. No evidence of slope instability was seen during the site inspection.

Figure 3: Photo of slope from below proposed dwelling location.

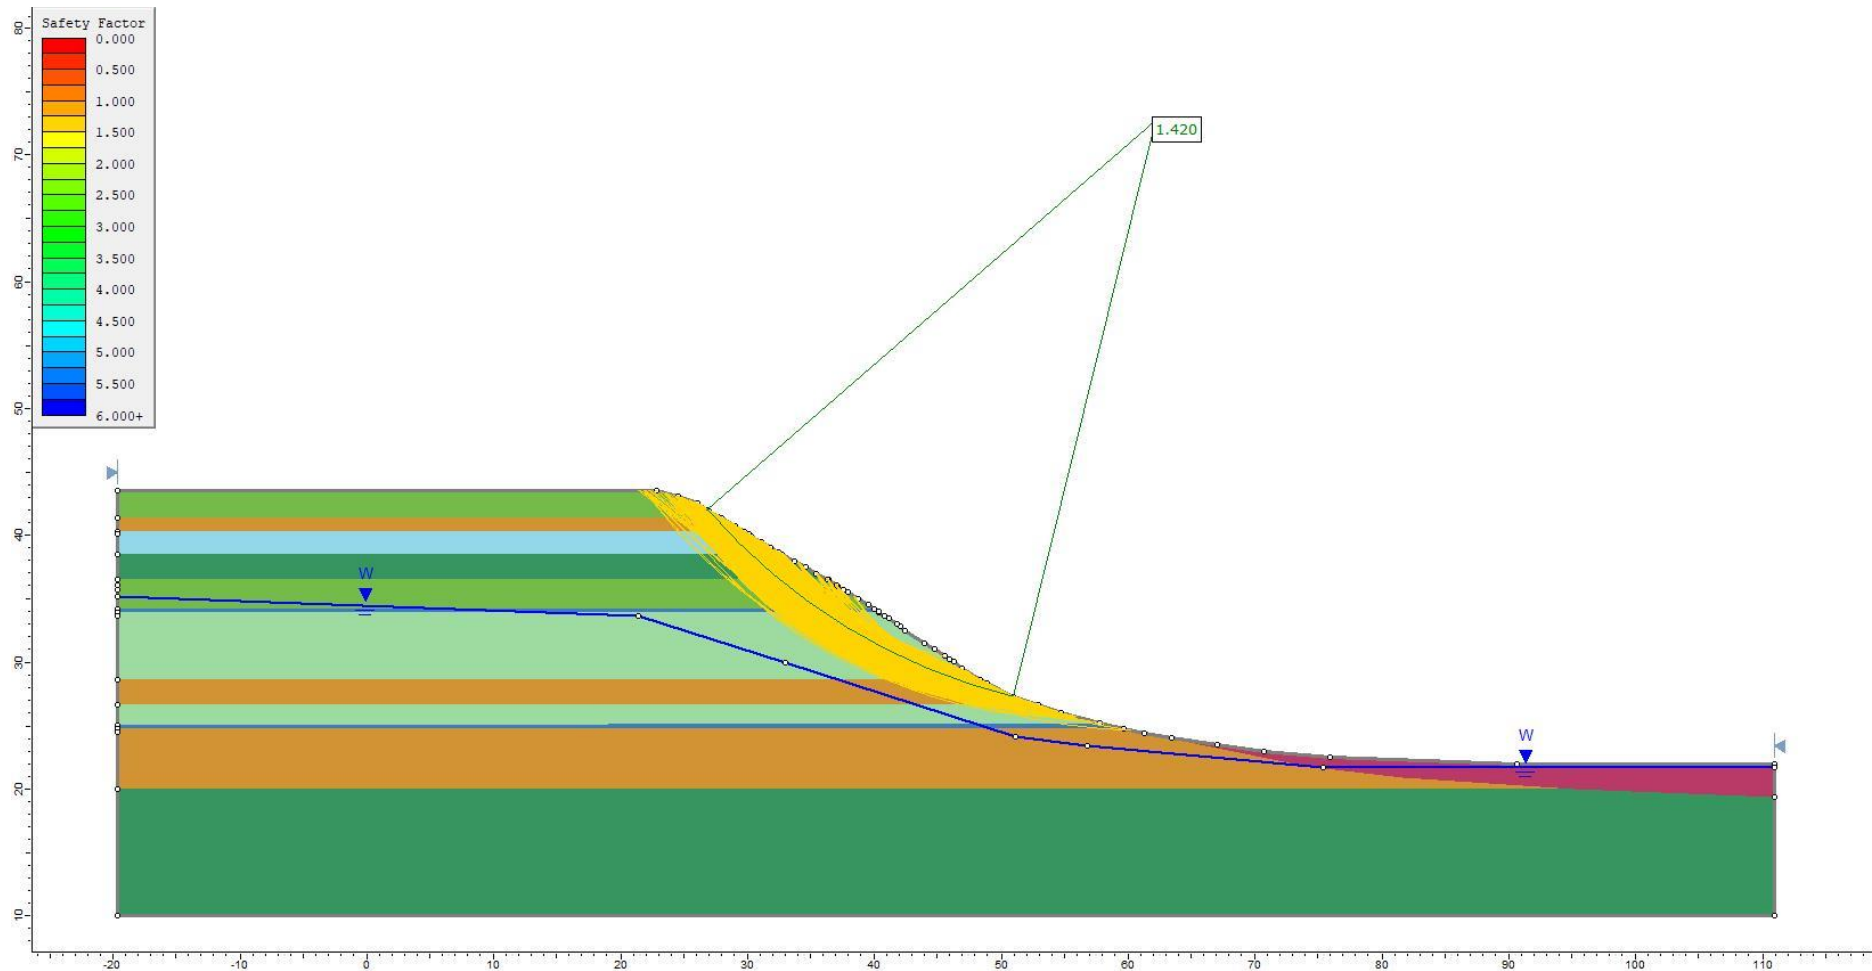
Under existing conditions, the model shows failure arcs below the required FOS up to 11.8m back from the crest of the slope during ULS and SLS conditions. The gravity condition had failure arcs below the required FOS up to 1.4m back from the crest of the slope.

SLIDE 2018 model – Existing Site – Gravity Conditions – FOS required: 1.5

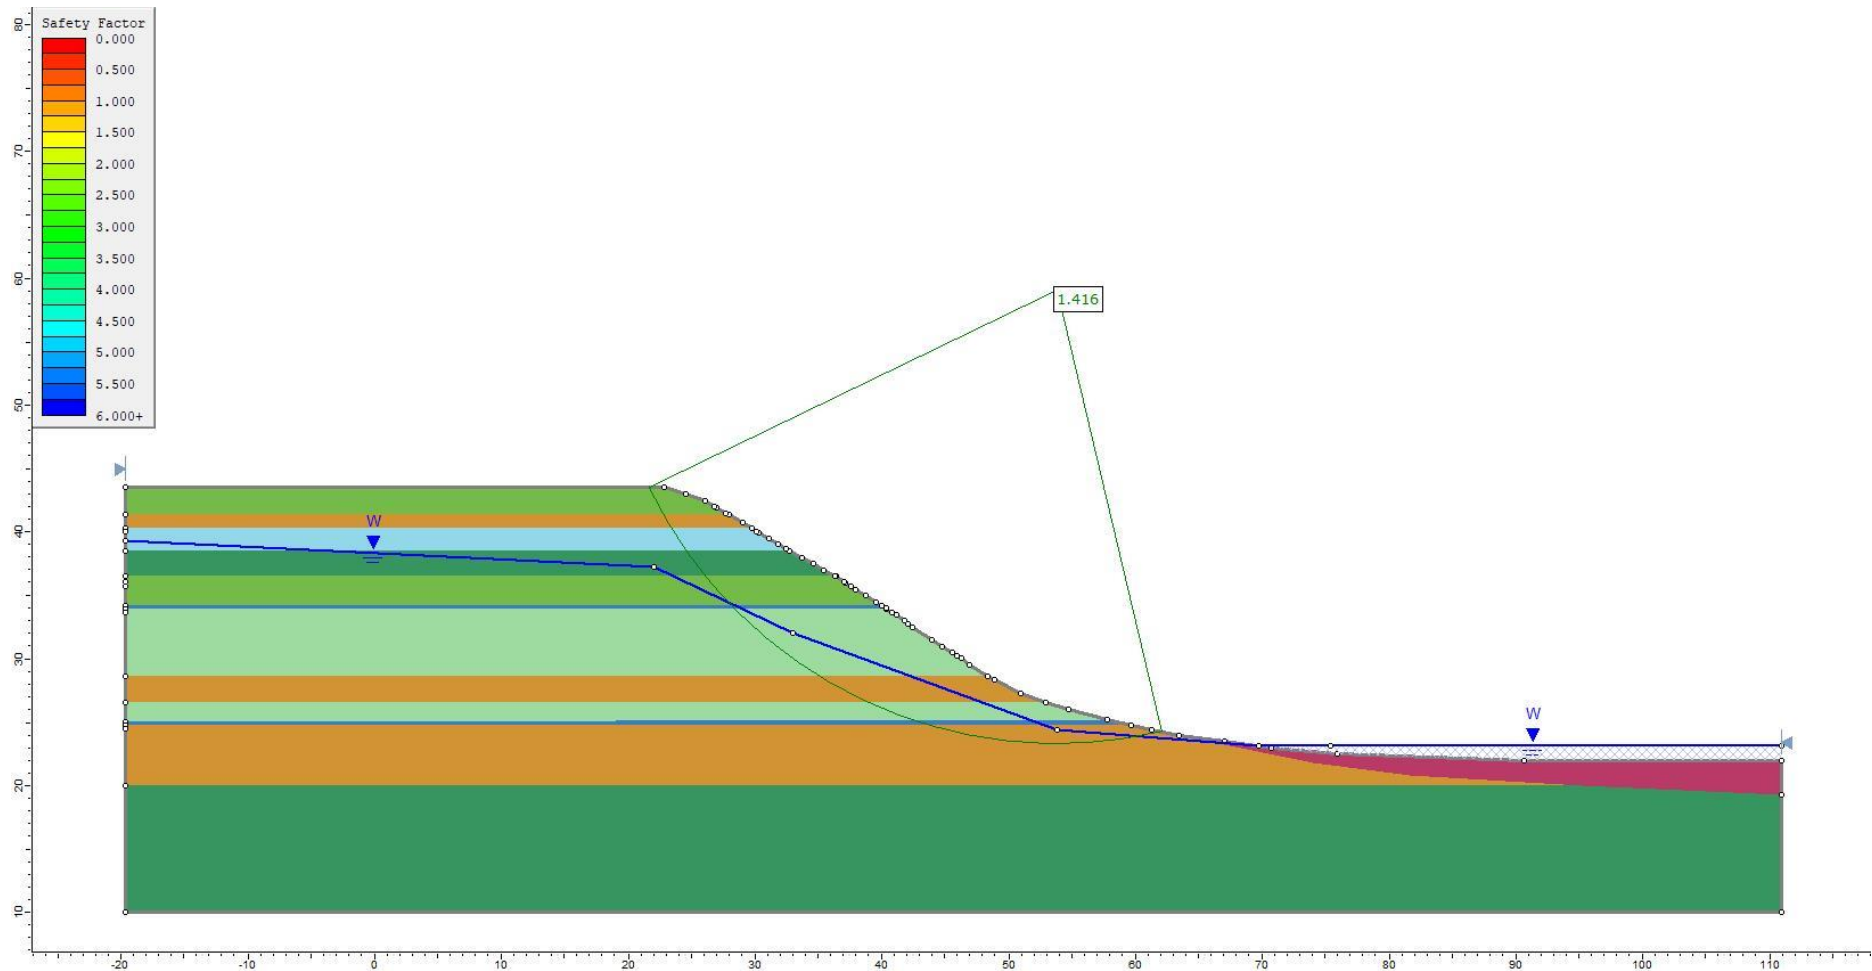
SLIDE 2018 model – Existing Site – Gravity Conditions –Elevated water table - FOS required: 1.3

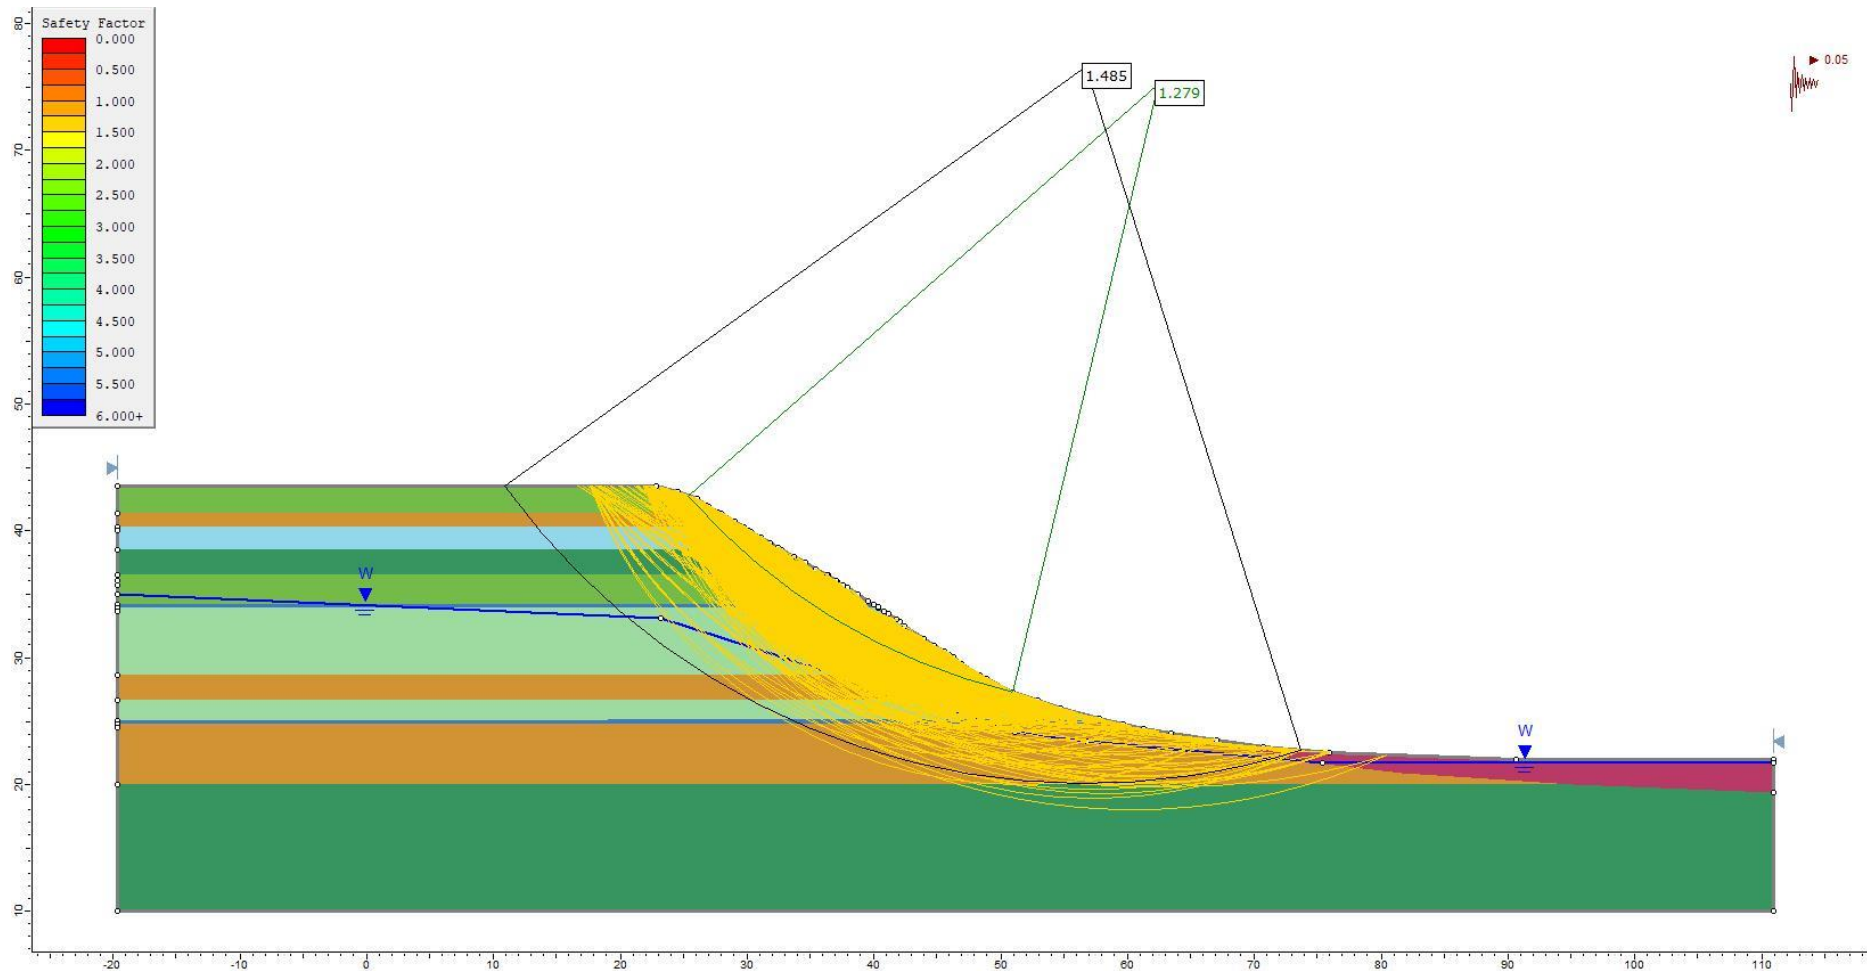
SLIDE 2018 model – Existing Site - SLS (Serviceability Limit State) – FOS required: 1.5

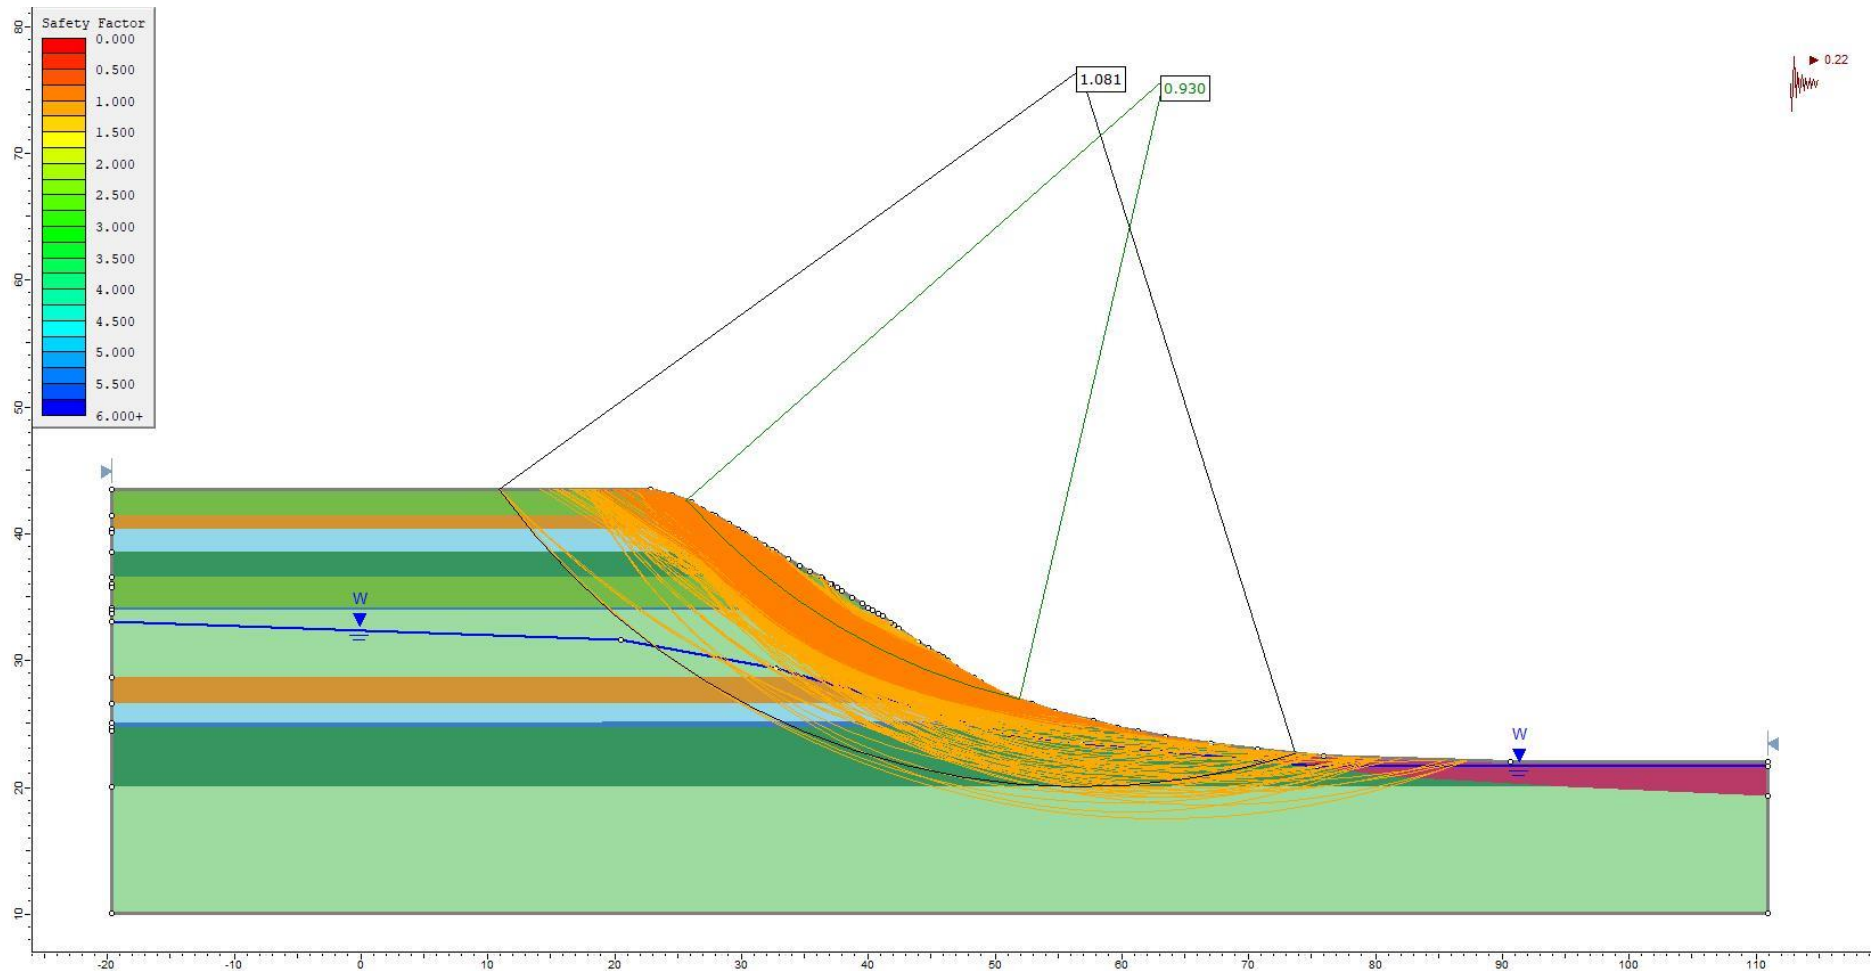
SLIDE 2018 model – Existing Site - ULS (Ultimate Limit State) – FOS required: 1.1

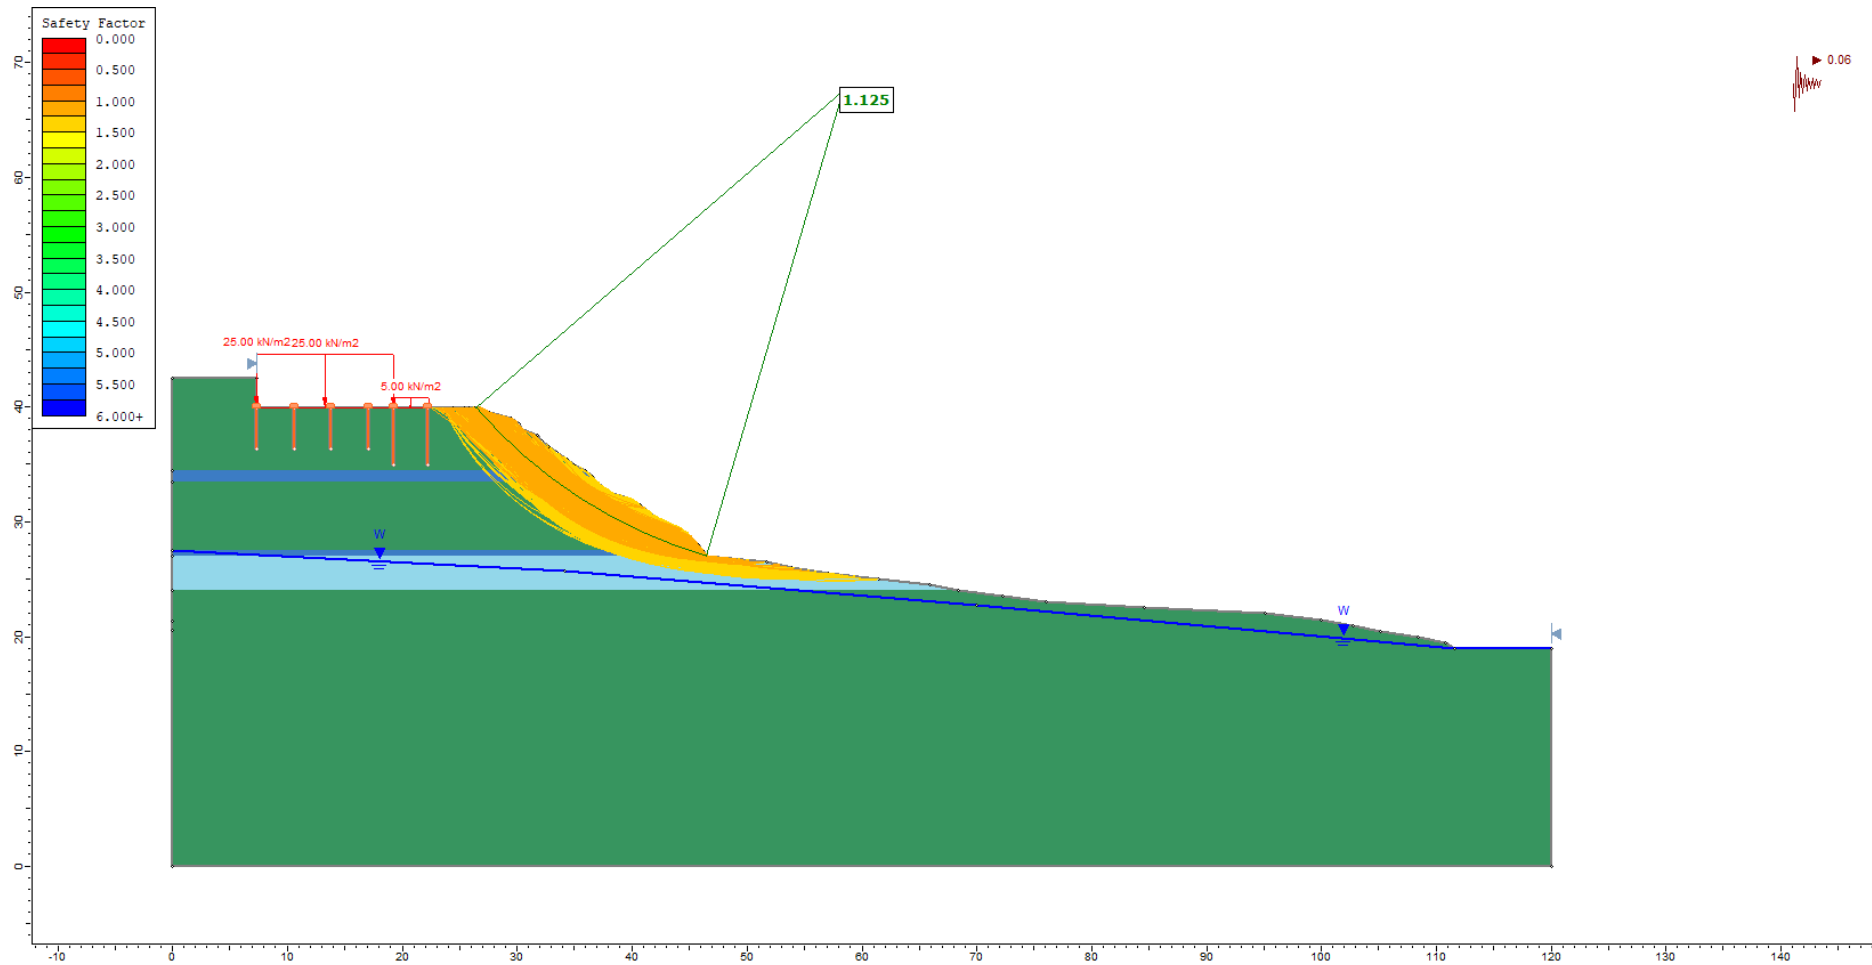
Under the proposed slope cutting and dwelling foundation scenario the gravity and elevated water scenarios meet the required FOS required. The FOS reached for the dwelling under the SLS condition was 1.55 and the FOS reached under ULS conditions was 1.11. Both of these meet the required FOS for their conditions.

SLIDE model – Proposed Dwelling - SLS (Serviceability Limit State) – FOS required: 1.4

- The dwelling should be setback at least 5.5m from the new top of the slope after cutting down with piling as modelled.
- The modelled foundation is based on 200mm diameter piles as per the Engineering Plans with a minimum embedment depth of 5.0m and 3.6m as modelled.
- The rest of the foundation piles will be designed by a suitably qualified engineer to be in accordance with suitable depths as outlined in section 2.4.1 of this report.
- Appropriate vegetation should be planted on the slope as to improve stability and avoid erosion.
- No overland flow paths should be directed onto or towards the slope.
- No undercutting of the slope should be undertaken without due consideration to slope stability.

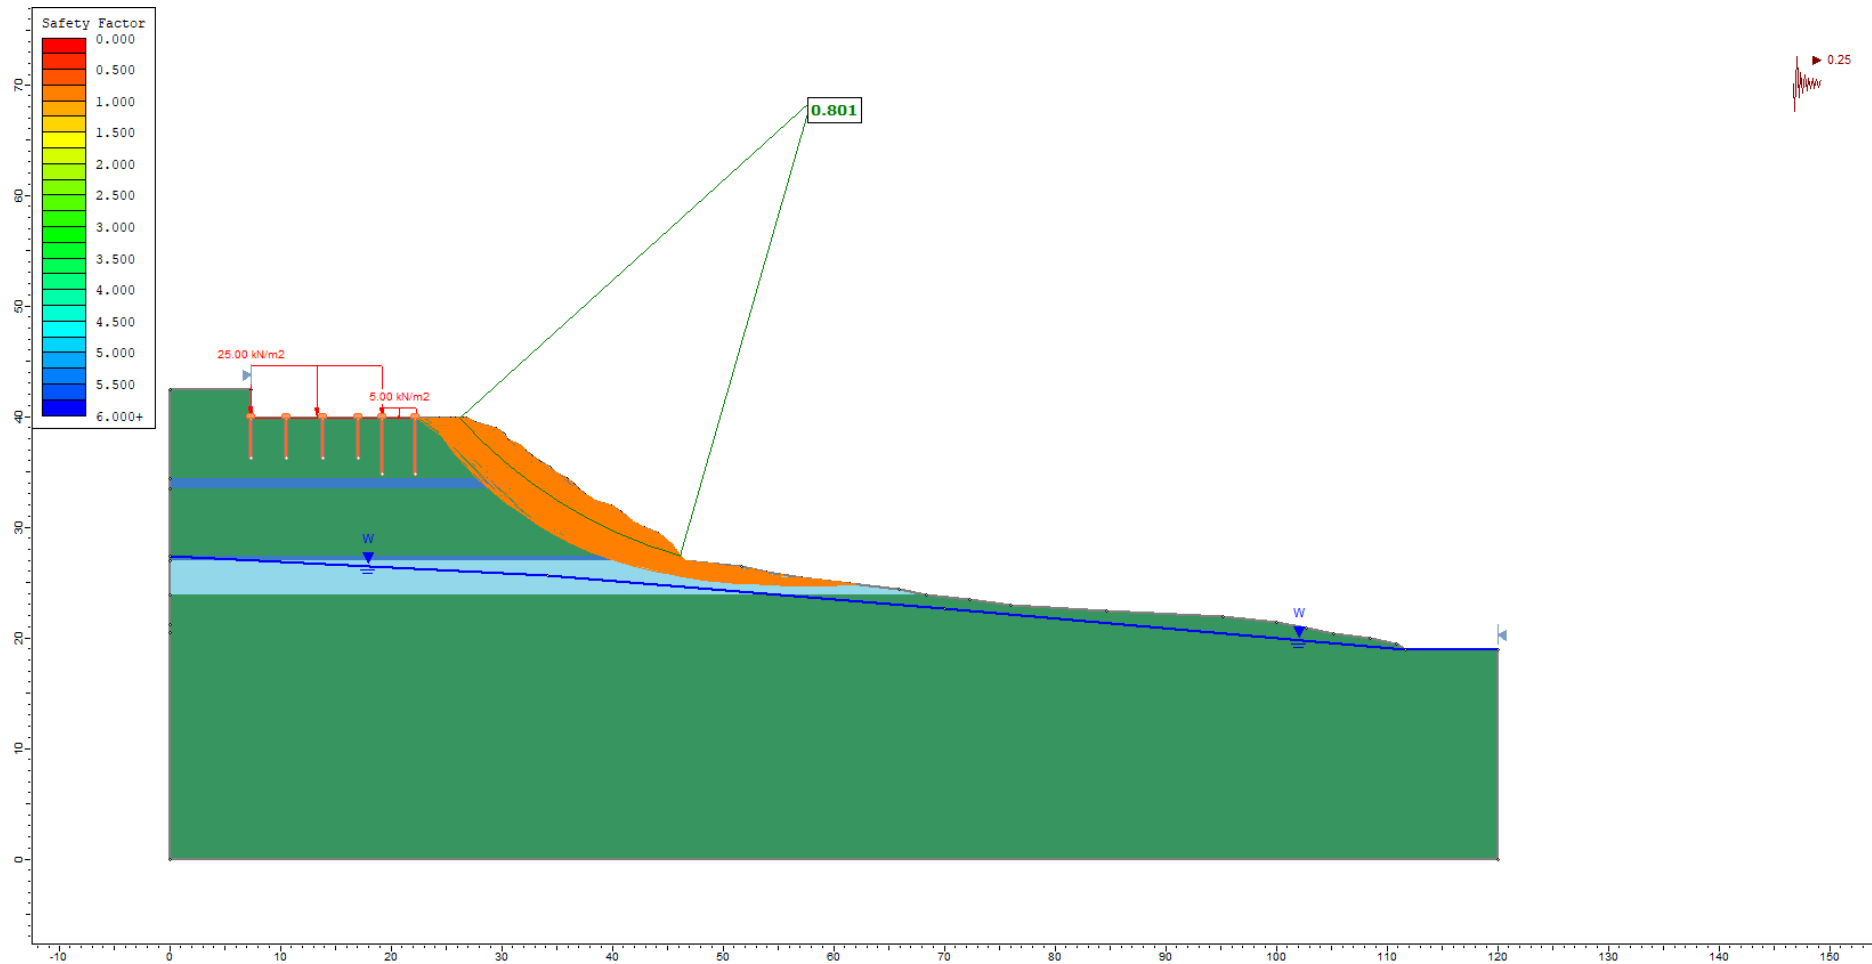
SLIDE model – Proposed Dwelling - ULS (Ultimate Limit State) – FOS required: 1.0

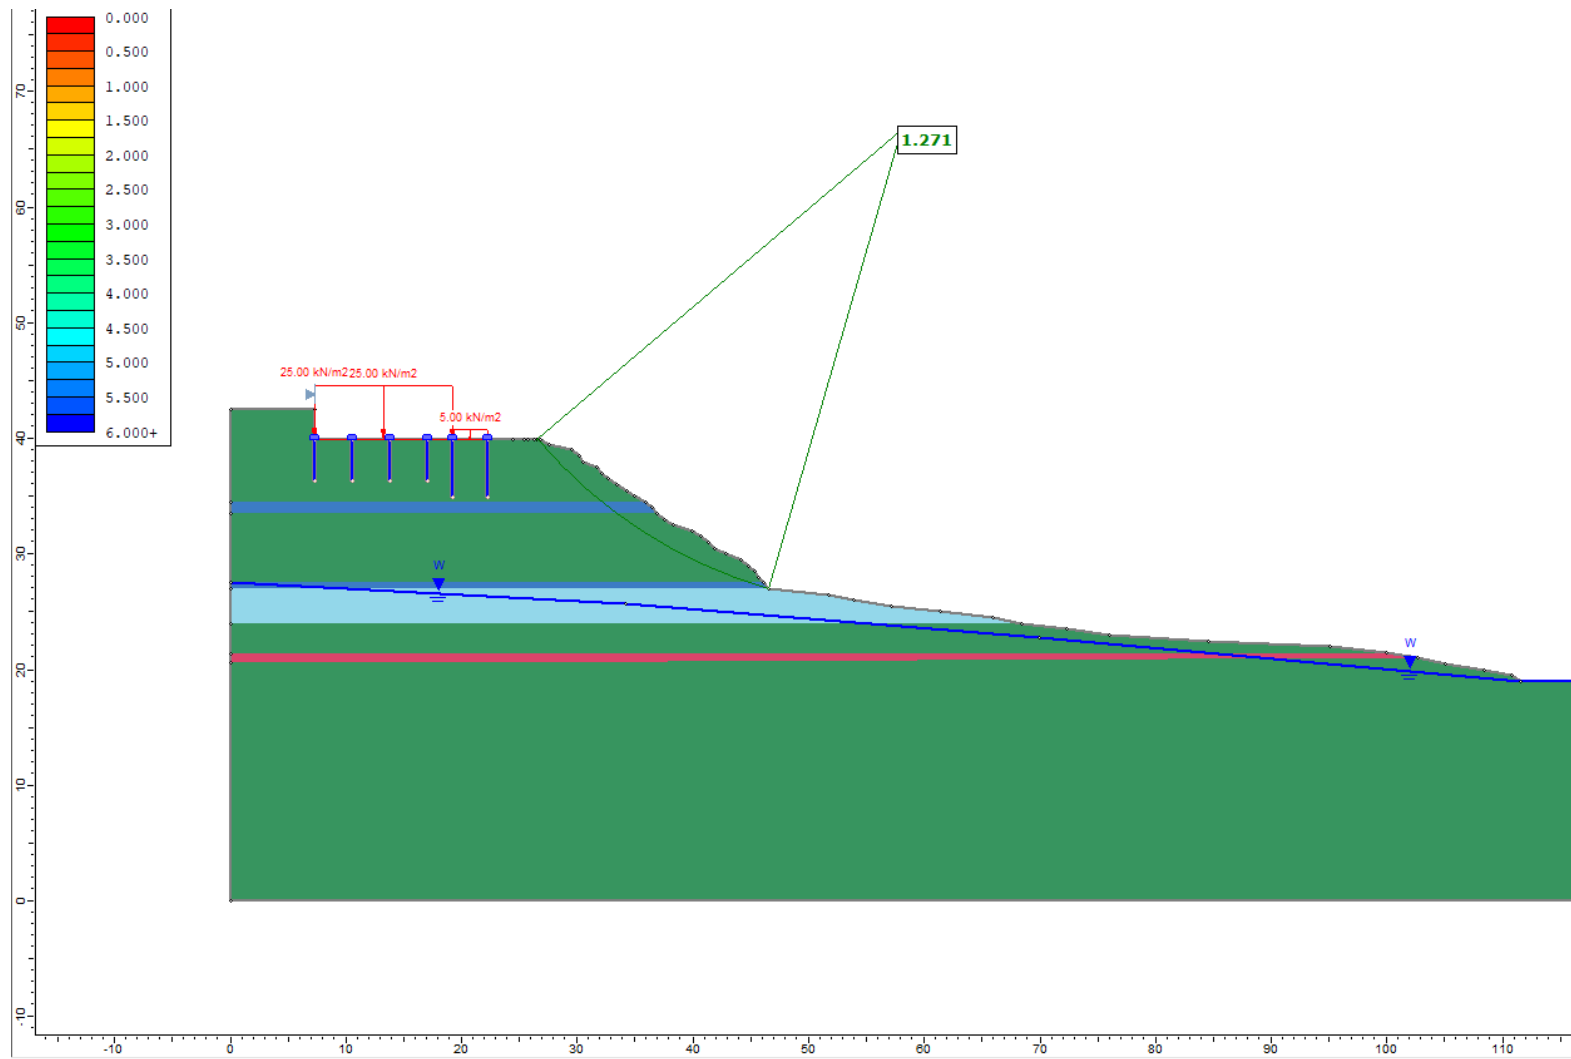
The strength loss scenario gave a FOS of 1.002 under ULS conditions.

SLIDE model – Proposed Dwelling – Strength Loss
