ENGINEERING ASSESSMENT AND DESIGN REPORT

Lot 2 136 State Highway 26,
Hamilton

PROJECT NO. 11122

TITUS
CONSULTING ENGINEERS

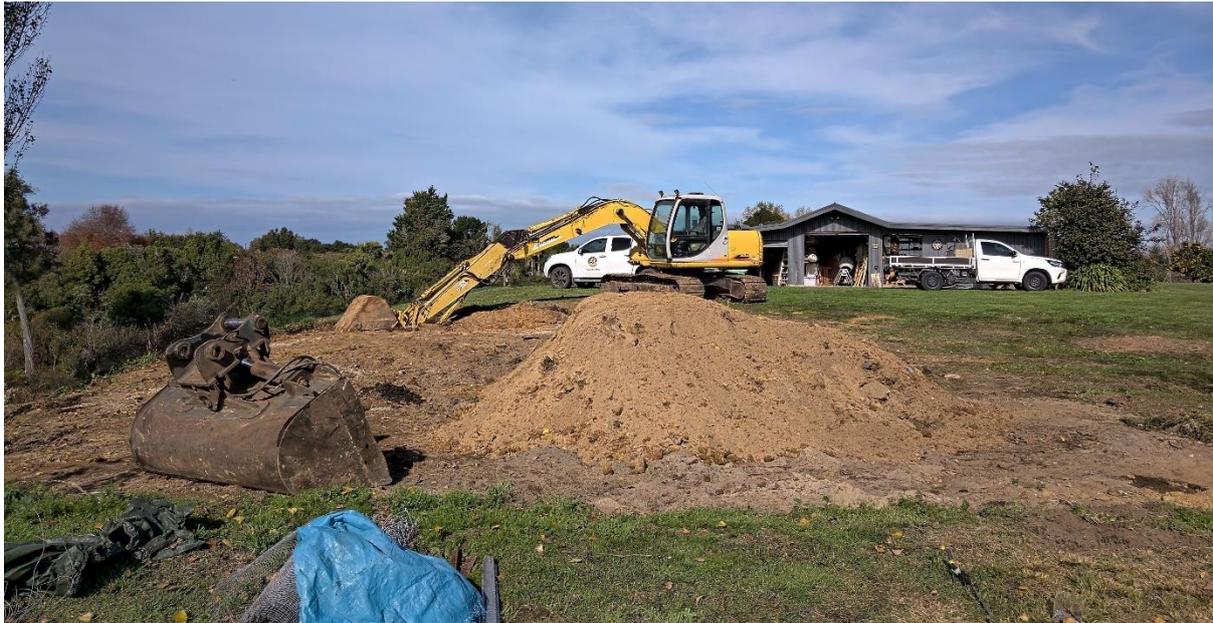
Figure 1: Site Photo

Figure 1 shows a photo of the proposed dwelling location.

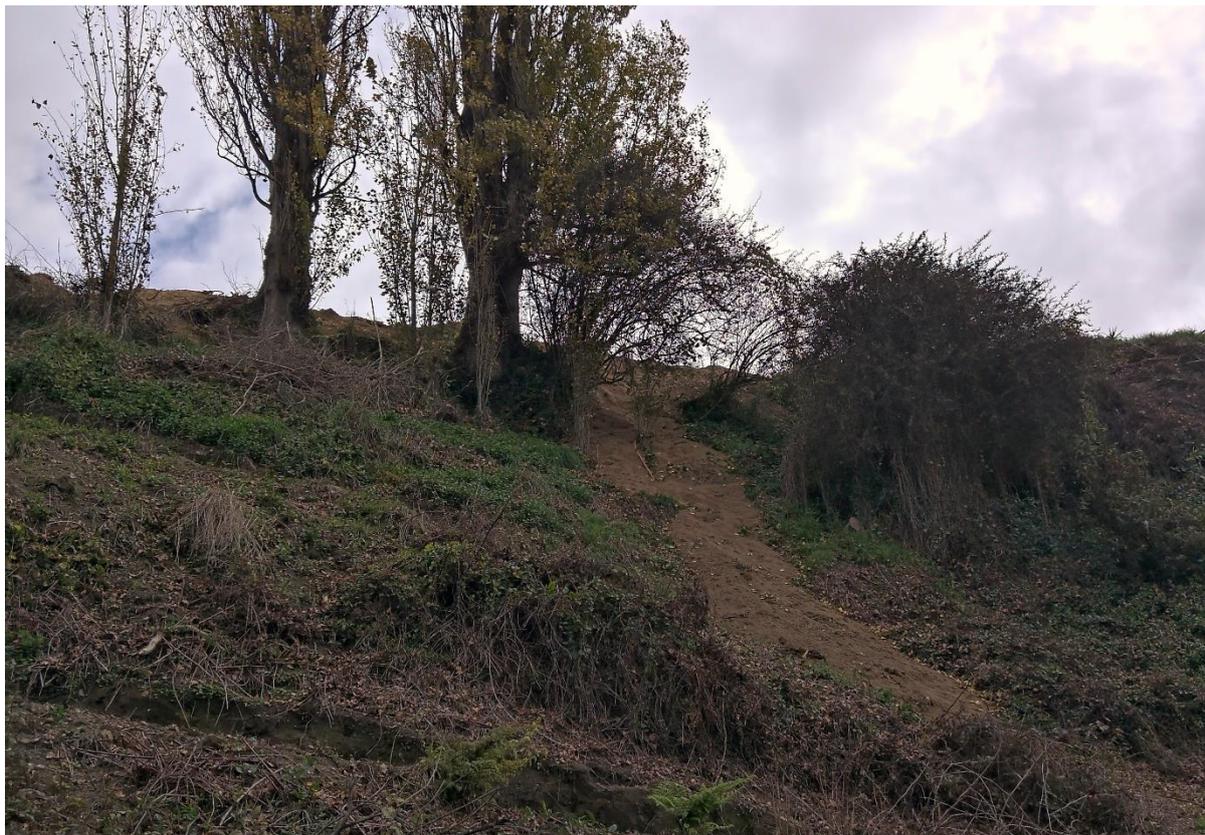
The slope runs across the site from north to south. The slope separates flat (<5%) land above it to the west from the vegetated gully below it. Vegetation on the slope itself has been cleared in preparation for specialised planting. There were no outcrops of rock found on site.

The slope ranges in steepness from 7 degrees to a maximum of 40 degrees with an average slope of 27 degrees or 51% incline. Two large poplar trees are present at the top of the slope. Figure 3 below shows the slope below the proposed dwelling location. The loose material seen on the slope in Figure 3 is sand from the removal of the milking shed foundation. No evidence of slope instability was seen during the site inspection.

Figure 3: Photo of slope from below proposed dwelling location.
